## LEARNING FROM INCIDENTS

### (Fire Incident at OMC's Retail Outlet in Lahore in May, 2021)

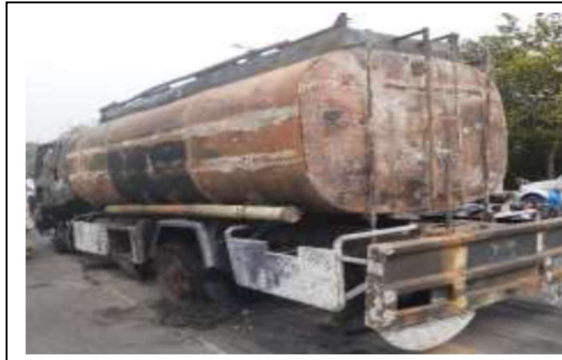
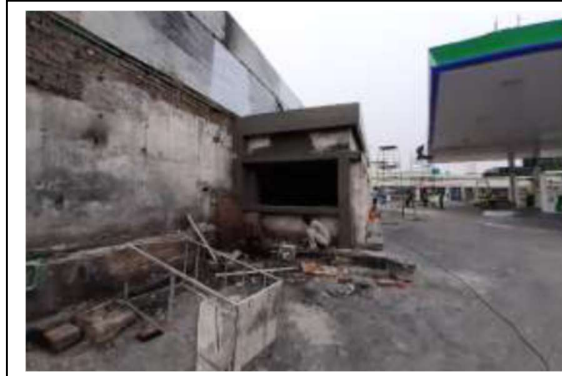
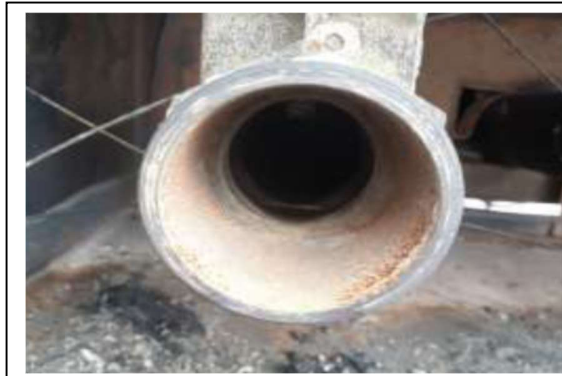
- Static Charge became possible source of ignition since Tank Lorry was not connected with Earthing at the time of Decanting.
- Standard Decanting Procedure was not followed by the Tank Lorry and the Fuel Station.
- Emergency Shut-Off Valve System was not Installed on Tank Lorry since the Pneumatic Shutdown system, in Standard Tank Lorry gets the Decanting Valve Closed in Case of Emergency.
- Local Gate Valves installed instead of API Adopter.
- Foot Valves not installed in Tank Lorry.

- Ensure Earthing before Decanting.
- Standard Decanting Procedure must be followed.
- Installation of Emergency Shutdown Valves on Tank Lorry be ensured.
- New Tank Lorries be introduced.
