LEARNING FROM INCIDENTS

(Fire Eruption in CNG Van at Tehsil & District Muzaffargarh in September, 2018)

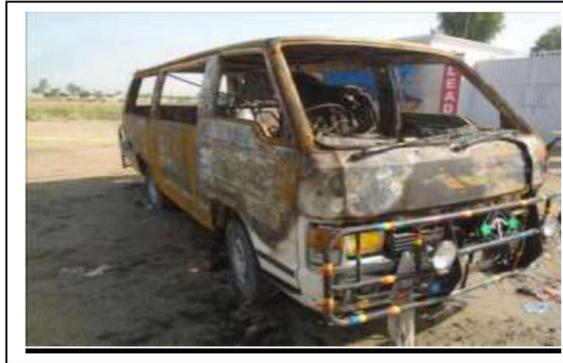
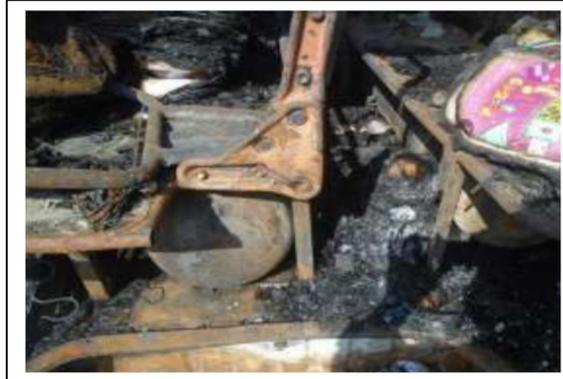
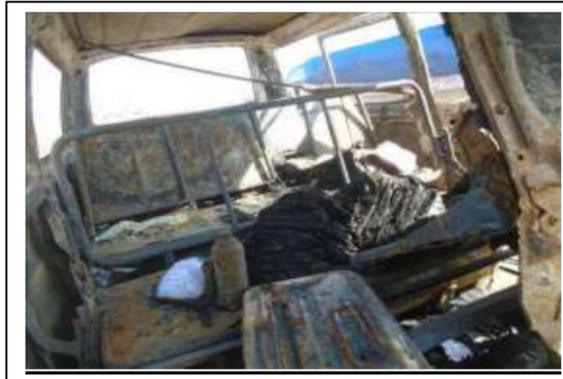
Causes of the Incident

- Sub-Standard CNG Kit and Poor Piping Connections of CNG Supply to Engine.
- Poor Electrical Wiring and Connections causing Short-Circuiting.
- Absence of Battery Terminal Insulation Covering.
- CNG Cylinders installed under the 2nd and 3rd Row of Passenger Seats.
- Battery Installed near the CNG Cylinder back to the Driver's Seat.

- Ban on Sub-Standards CNG Kits and Poor Piping Connections.
- CNG Kits should only be installed by OGRA Authorized Workshops.
- RTA Fitness Certificates should be made Mandatory and be checked by Local Traffic Police.
- Proper Electrical Wiring and Connections be ensured.
- Proper Battery Terminal Insulation Covering be Installed.
